# Quantification of Corona Discharges on Nonceramic Insulators

B. Pinnangudi, R. S. Gorur and A. J. Kroese \*

**Abstract:** This paper attempts to establish a correlation of the visual images of corona obtained from a camera with discharge magnitude measured with conventional partial discharge equipment. A linear relationship is shown between the transformed image parameters and the discharge magnitude, thereby providing a means for quantifying corona observations made during routine maintenance inspections of insulators from ground. Different insulator designs using silicone rubber (SIR) and ethylene propylene diamene monomer (EPDM) housings were examined. The effect of fog has been examined by performing experiments inside a fog chamber. It is shown that this information can be used along with the corona degradation characteristics of housing materials to identify discharge patterns that can pose problems to the integrity of the insulator.

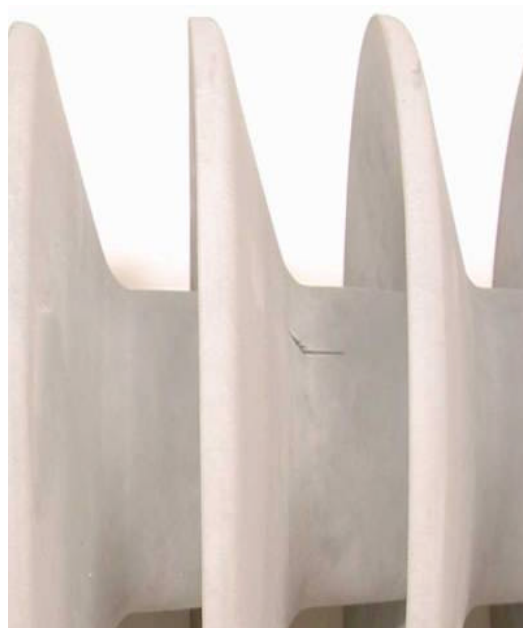
Figure 1: Corona cutting of the housing material of two different 230 kV NCI without corona rings in two different stages of degradation. Fig. 1a shows the advanced stage, and Fig. 1b shows degradation in early state.

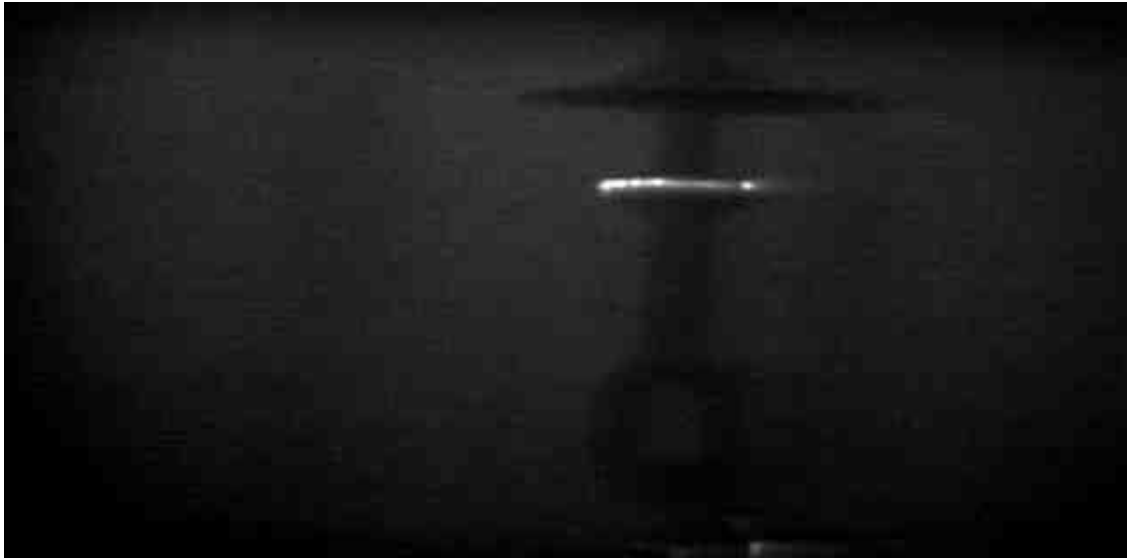
Figure 6: Corona at 50 kV (0.75 p.u) of magnitude 30 pC from a weathered hardware of a silicone insulator under dry conditions, fig. (a) and corresponding intensity plot fig. (b).

Any increase in the voltage from the inception value resulted in higher discharge magnitudes (measured by PD detector), as shown in Fig. 6 and Fig. 7. By using the proposed technique the intensity plots were constructed and cumulative intensities were determined. The cumulative intensity values were approximately zero and 150 arbitrary units in the transformed parameter scale corresponding to 30 pC and 2 nC discharge magnitudes respectively. The increase in discharge magnitude is manifested as an increase in the transformed parameter values [16, 17, 18]. It is interesting to note that corona was observed even below the normal operating voltage, and this is attributed to the hardware that was weathered during field use.

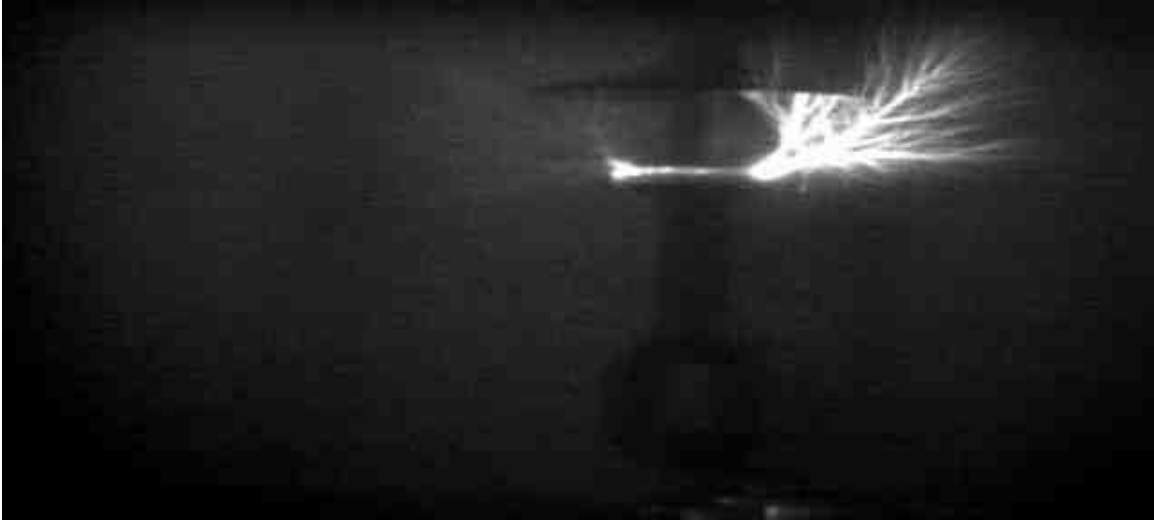
Figure 7: Corona at 80 kV (1.2 p.u) of magnitude 2.0 nC from a weathered hardware of a silicone insulator under dry conditions, fig. (a) and corresponding intensity plot fig. (b).

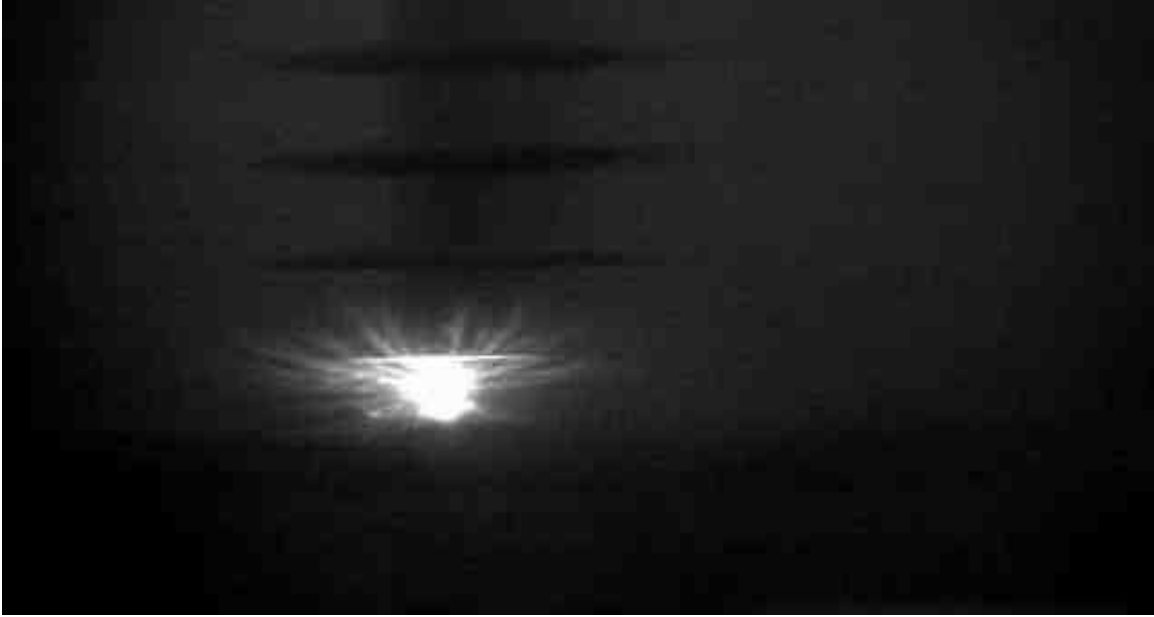
Figure 11: Discharge on EPDM insulator at 80 KV (1.2 p.u) under wet condition, fig. (a) and corresponding intensity plot, fig. (b)

To study the effects of the housing material on the suggested technique, the above experiments were replicated on an EPDM insulator whose design is shown schematically in Fig. 5b. Figs. 10 and 11 are corona images and their corresponding intensity plots for this EPDM insulator. The cumulative intensities were found to be 12 and 140 units in the transformed parameter scale. The discharge magnitudes corresponding to the transformed parameter values

were found to be 0.1 nC and 1.85 nC by using Figs. 8 and 9. The PD measurements corresponding to corona observed in Figs. 10 and 11 with the PD detector were 0.2 nC and 1.9 nC. The calculated values from the proposed technique hence matched well with the discharge magnitudes measured by the PD detector. It is interesting to note the occurrence of corona at the interface between the individually jointed sheds under wet conditions even for a new insulator. Fig. 12 is a three dimensional representation of the plot shown in Fig. 11b, from which it is easier to visualize the location of corona discharge on the insulator.

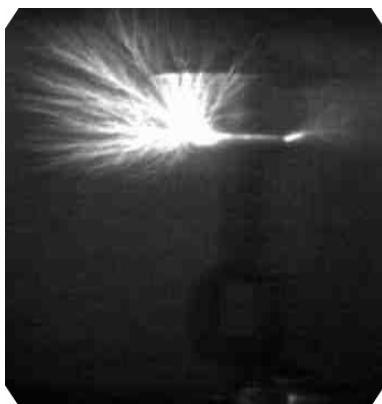
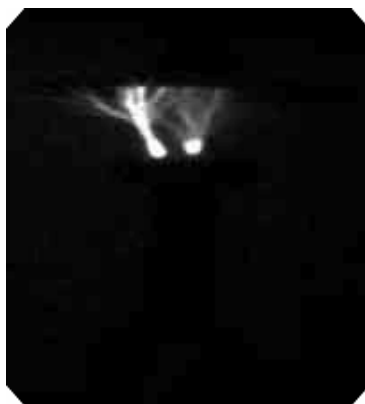
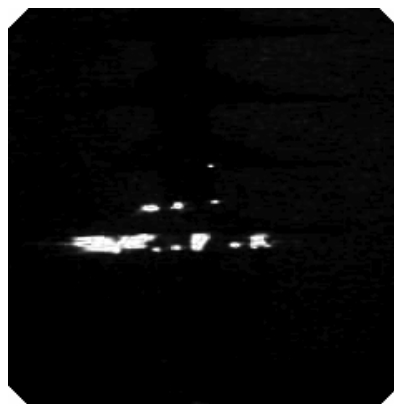
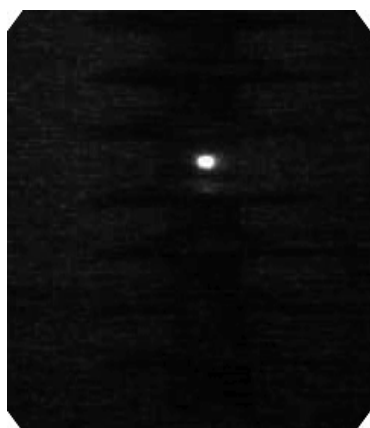
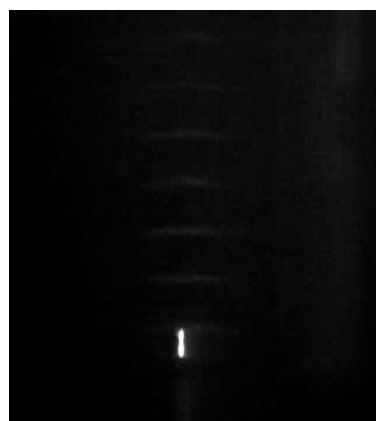
Figure 13: Typical corona on NCI

(a) Corona on hardware at 75 kV (1.1 p.u) under dry conditions

(b) Corona from water drops on the hardware at 30 kV (0.45 p.u)

(c) Corona from water drops on weathershed at 50 kV (0.75 p.u)

(d) Corona from water drops in the interface of shed and shank at 40 kV (0.60 p.u)

(e) Corona in the shank between hardware and the first shed at 60 kV (0.9 p.u) under wet conditions

- ? The hardware of the insulator even under dry conditions in the absence of a grading ring, as shown in Fig. 13a.
- ? The hardware and the hydrophobic housing material, especially in the presence of water droplets. This is shown in Figs. 13b and 13c
- ? Interfaces created by joining individual sheds (Fig. 5) especially in the presence of water droplets. This is shown in Fig. 13d.
- ? The shank portion between high voltage end fitting and first shed especially under wet conditions, as shown in Fig. 13e.

Knowledge of the discharge location is important. Discharges that occur on the hardware and/or far from the housing material are less damaging when compared to discharges that occur on or in close proximity to the housing. The ratio of the cumulative intensity to the area of the illuminated pixels is a measure of the corona discharge density and could be a good predictor of degradation. On visual observation of Fig. 13 and from Figs. 14a and 14b, it might appear that the corona corresponding to Figs. 13d and 13e have no significant damaging effect when

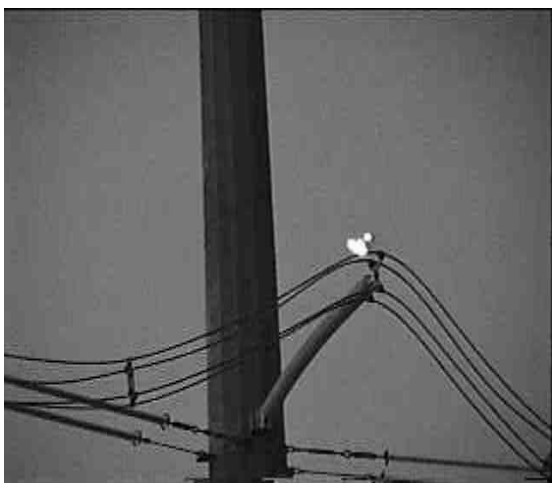
Figure 18: Quantification of corona discharges observed in the field using the proposed method

(a) Corona originating at the metal fittings of a 500 kV jumper line post NCI operating in a desert environment

(b) Processed corona image corresponding to Fig. 18 (a)

(c) Intensity Plot corresponding to corona seen in Fig. 18 (b)

corona camera and the region of discharge was estimated to be 50 meters. Fig. 17 represents corona on a 230 kV first generation EPDM insulator design with individually jointed sheds (Fig. 5b), used in earlier experiments for this paper. This insulator was installed more than 20 years back without corona rings, as the need for corona rings was not discovered at that time. Fig. 18 shows a 500 kV line post insulator used as a jumper in a substation. The presence of the bundled conductor and the large size of the line end hardware were thought to provide adequate electric stress grading, hence no additional rings were installed. The corresponding processed image and intensity plots are also shown in these figures.

The cumulative intensity was determined to be 55 and 37 (Arbitrary Units) for Figs. 17 and 18 respectively. The corona discharges seen in Fig. 17 can be more harmful than the discharges observed in Fig. 18 due to its proximity to the housing material and the effective magnitude of discharges that terminate on the shed. From Figs 15 and 16, it is determined that the images corresponded to partial discharge magnitudes of 3 nC and 2 nC respectively.
